SVE BULLETIN

QVM BULLETIN: Q-341 DATE: 21 / SEPT / 2011

SUPERDUTY POWER DISTRIBUTION BOX COVER

MODEL(S) AFFECTED:
2017 Model Year to Present Super Duty

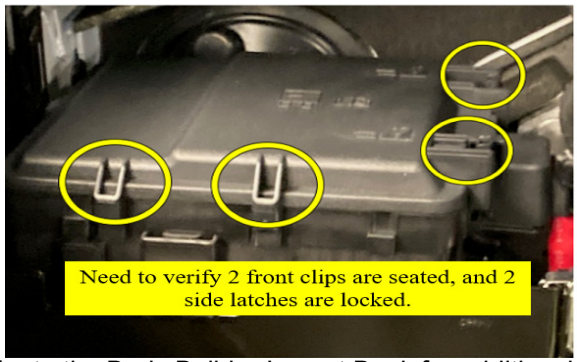
ISSUE / DESCRIPTION:
Warranty claims for damage to the Power Distribution Box due to water intrusion are being received as the cover to the Power Distribution Box is not being properly re-installed during vehicle upfits. **This is not a warrantable condition.** ***Vehicle Upfitters must ensure that, if the Power Distribution Box cover is removed as part of a vehicle upfit, the cover must be re-installed correctly in order to prevent water intrusion and potential damage to the vehicle electrical system.***

Example of incorrect latching of the PDB cover.

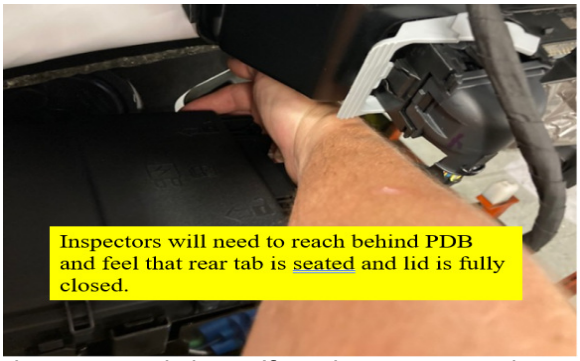
Example of correct PDB cover latching
